SUBJECT: Addendum No. 1
Hiwassee Utilities Commission
Water Treatment Plant Concrete Clearwell Baffle Replacement

ADDENDUM NO. 1

EXTRACT FROM
FEBRUARY 2023 INSPECTION

NOTE: THE TANK WAS OUT OF
SERVICE FOR FLOOR CLEANING
AND BAFFLE INSPECTION.

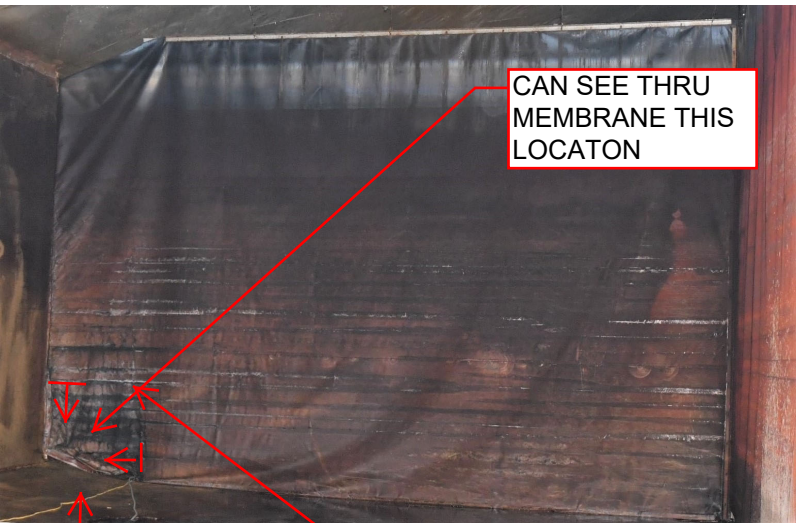
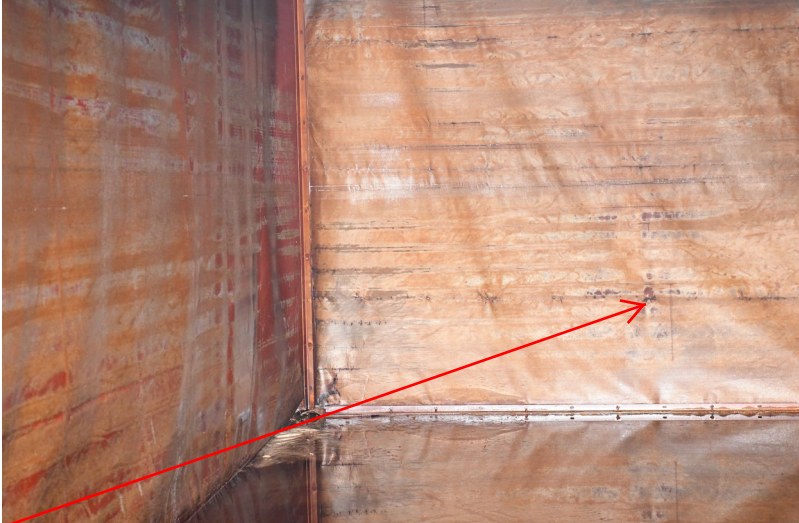
CAN SEE THRU
MEMBRANE THIS
LOCATON

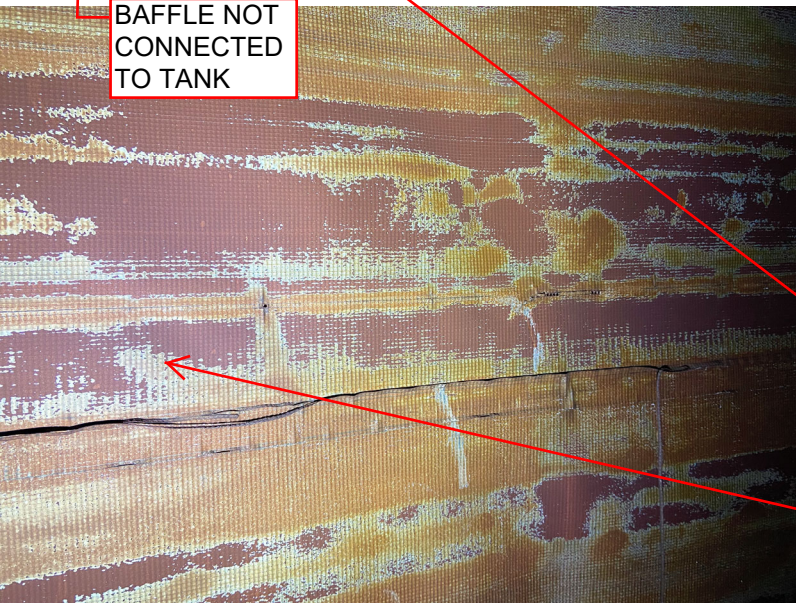
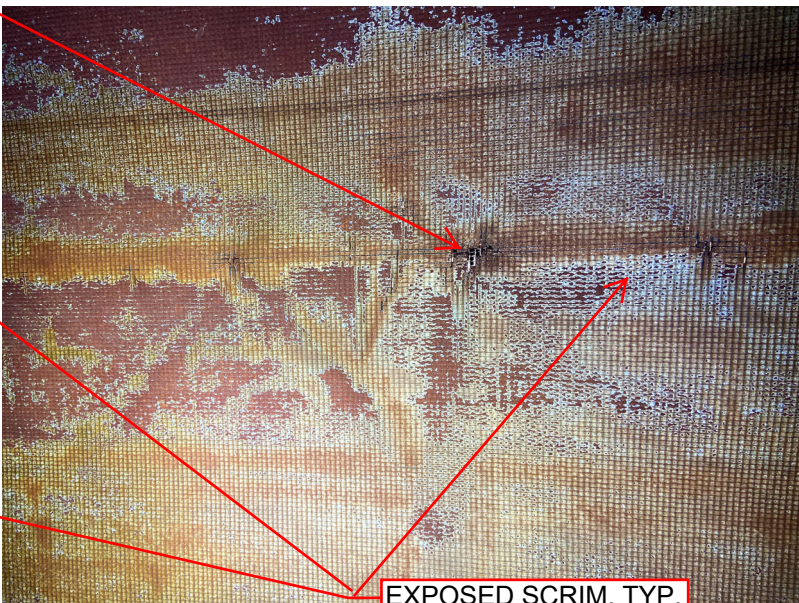
BAFFLE NOT
CONNECTED
TO TANK

HOLES, TYP.

EXPOSED SCRIM, TYP.

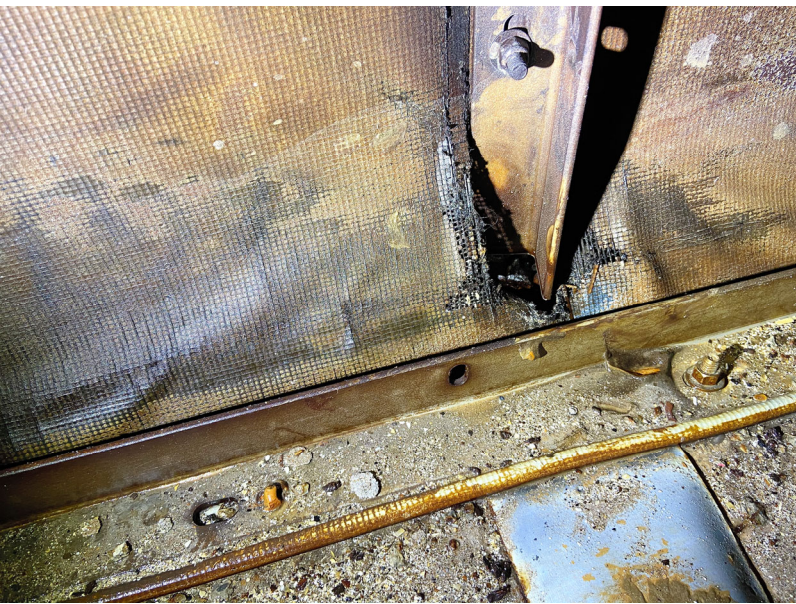
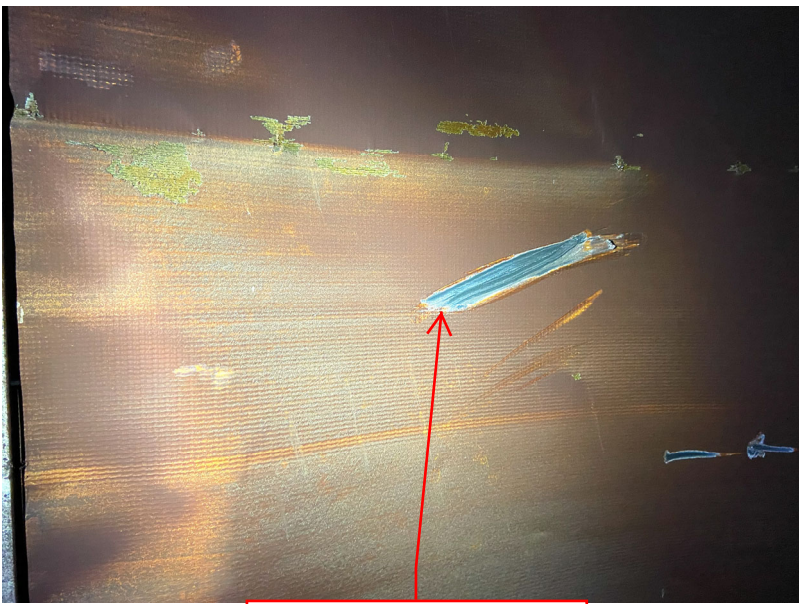
BUILDUP ON MEMBRANE
PARTIALLY REMOVED

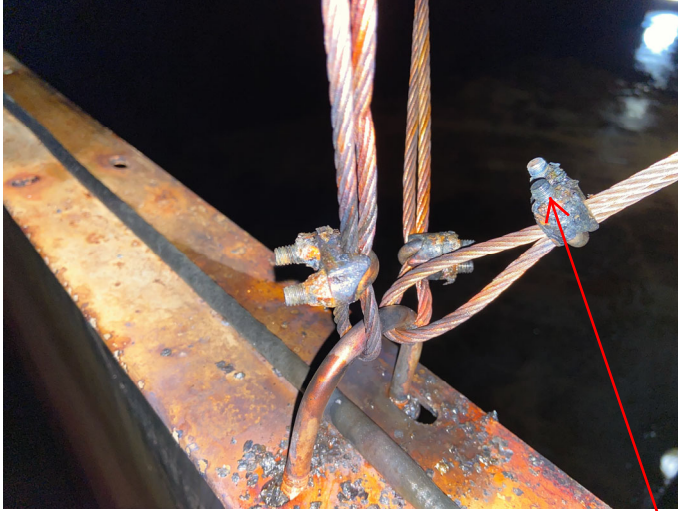
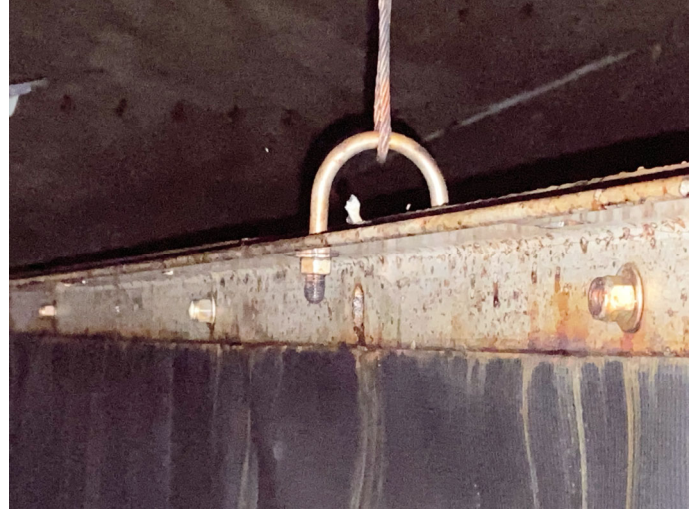
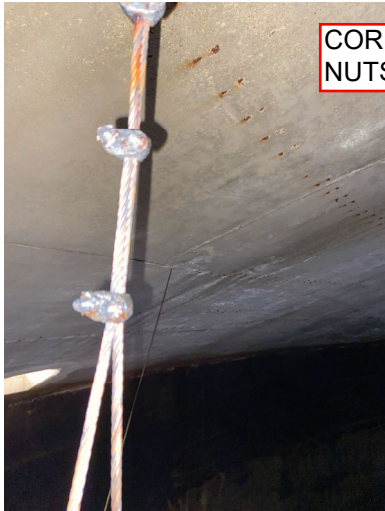
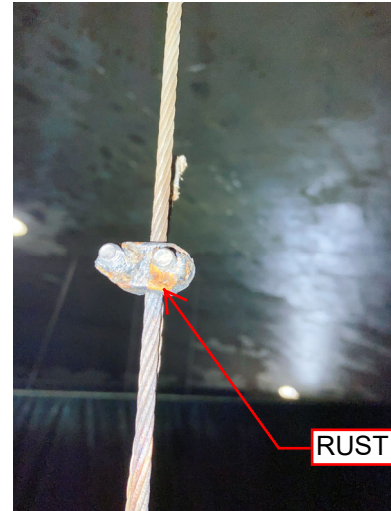
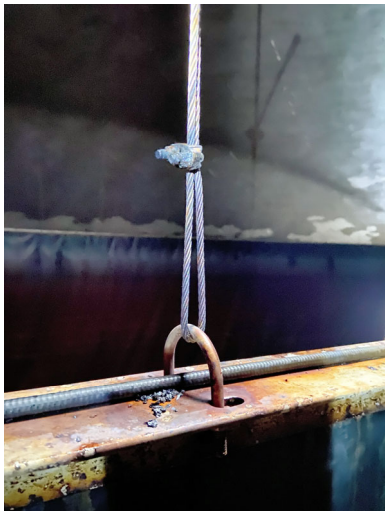
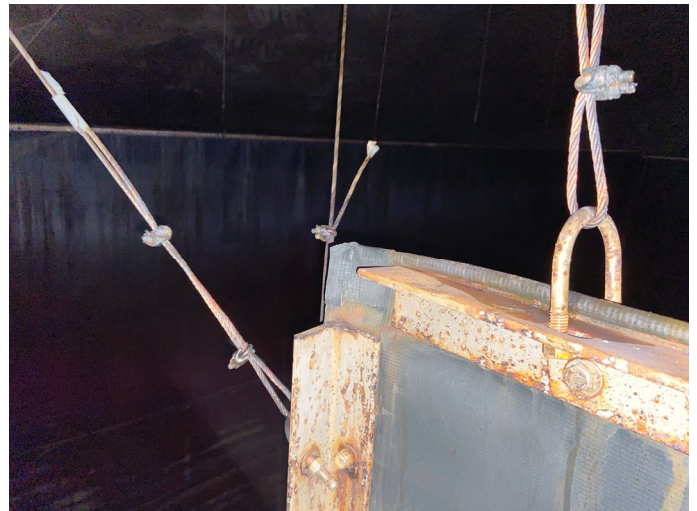
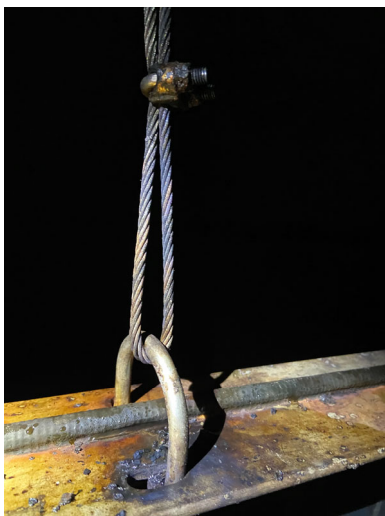
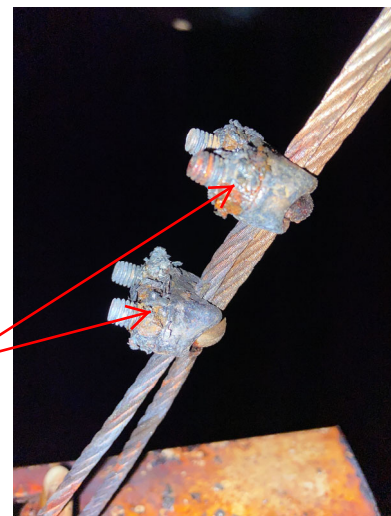
VIEWS OF TYPICAL
CABLE CONNECTIONS

CORRODED
NUTS, TYP.

RUST

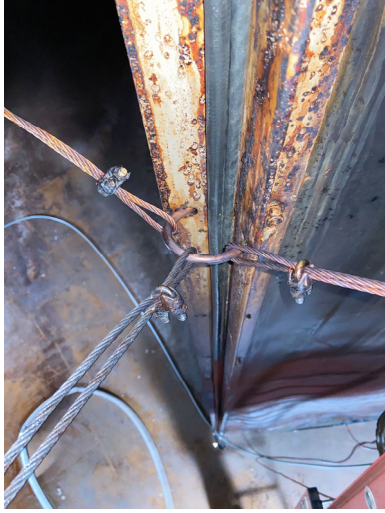
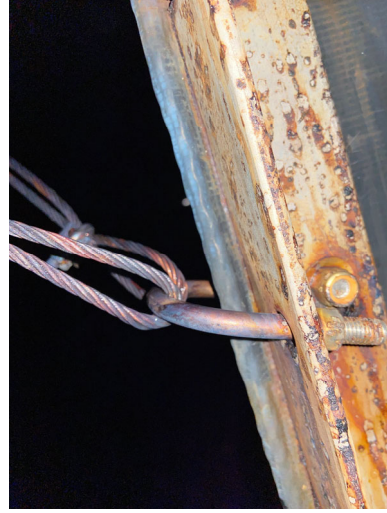
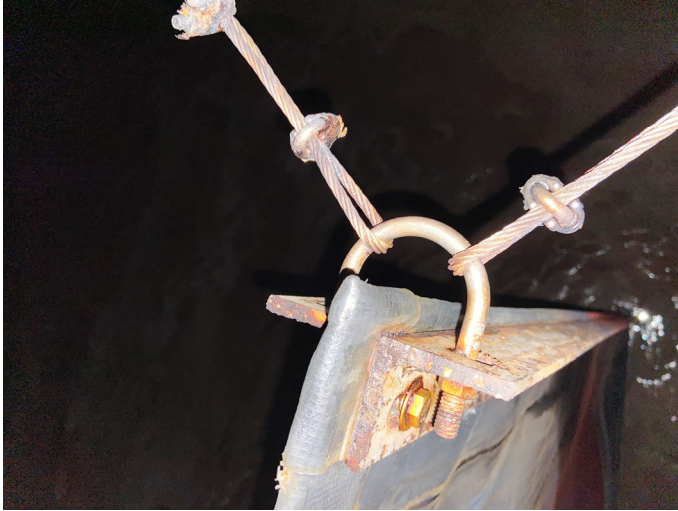
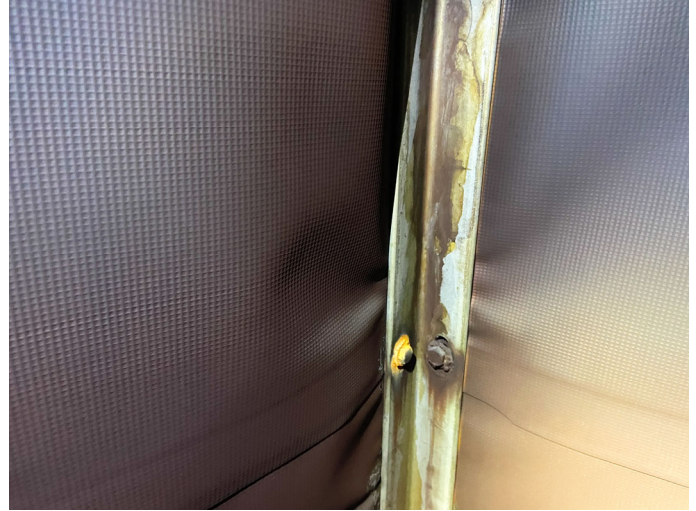
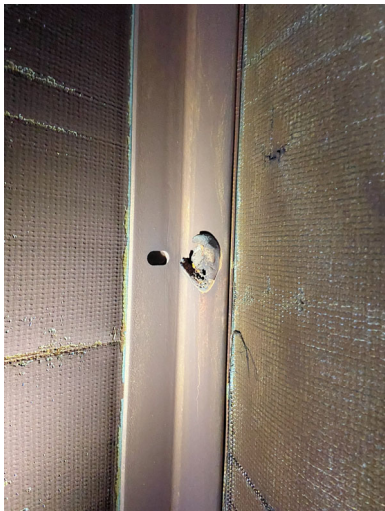
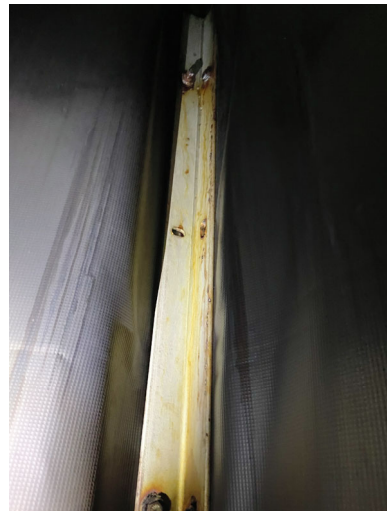
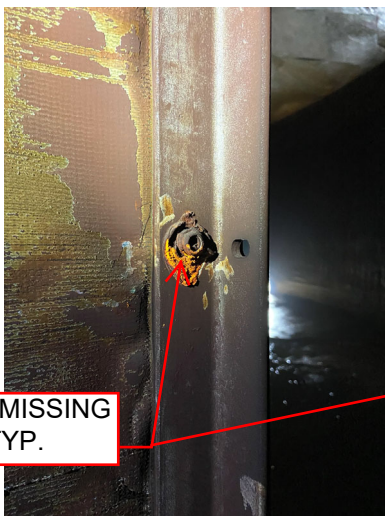
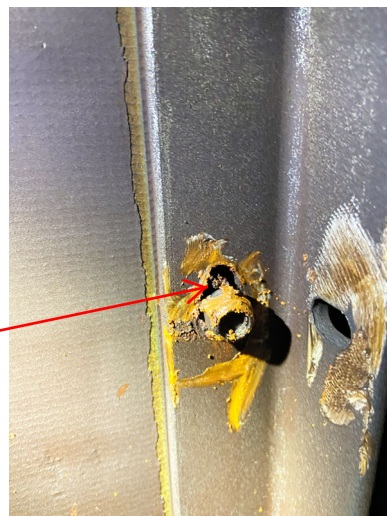
VIEWS OF TYPICAL
VERTICAL
CONNECTIONS

CORRODED/MISSING
WASHERS, TYP.

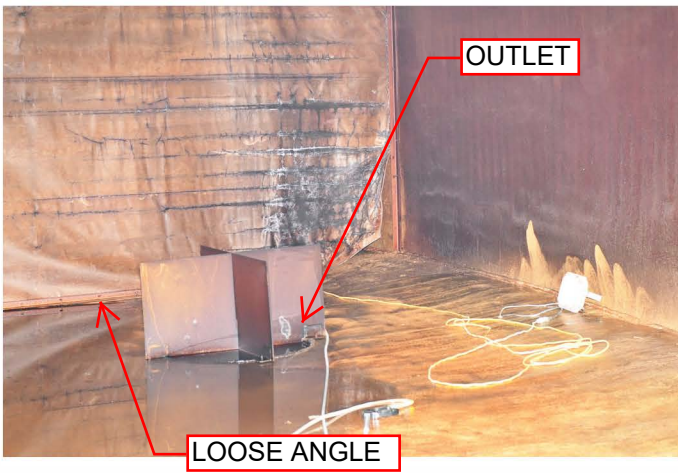
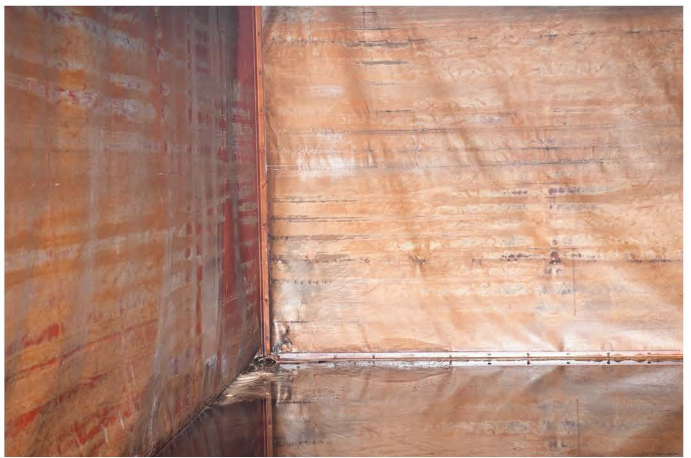
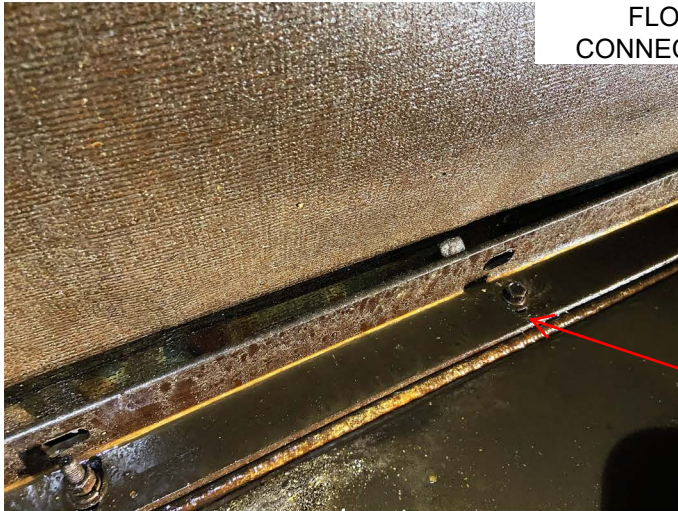
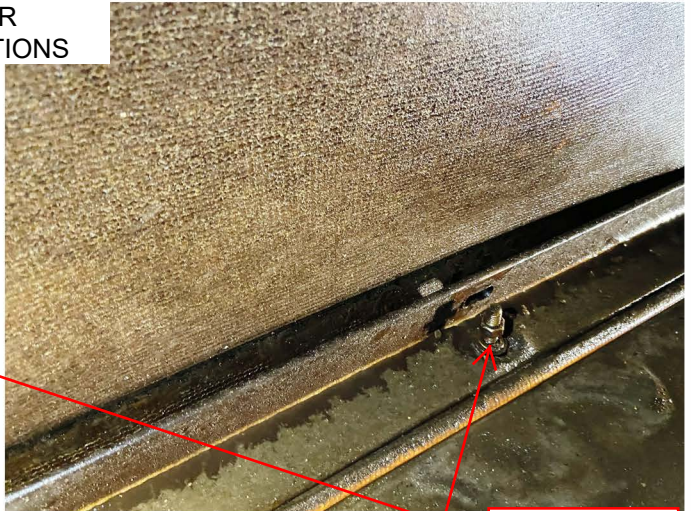
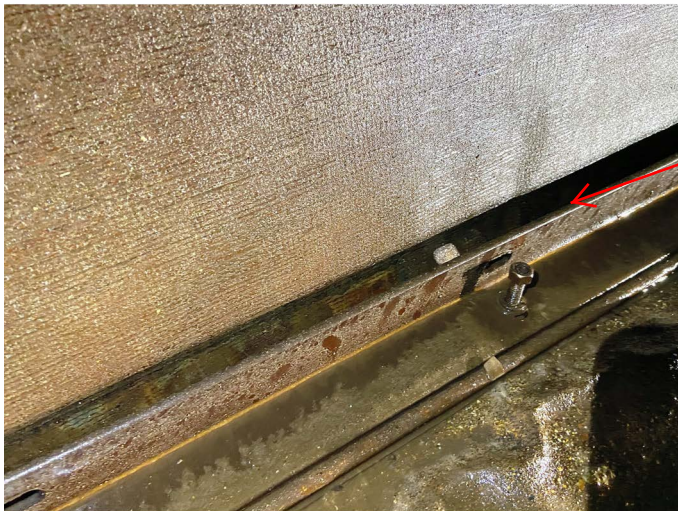
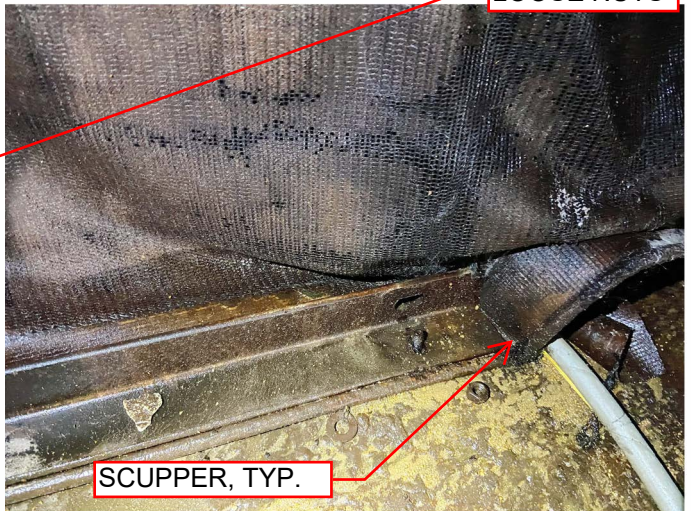
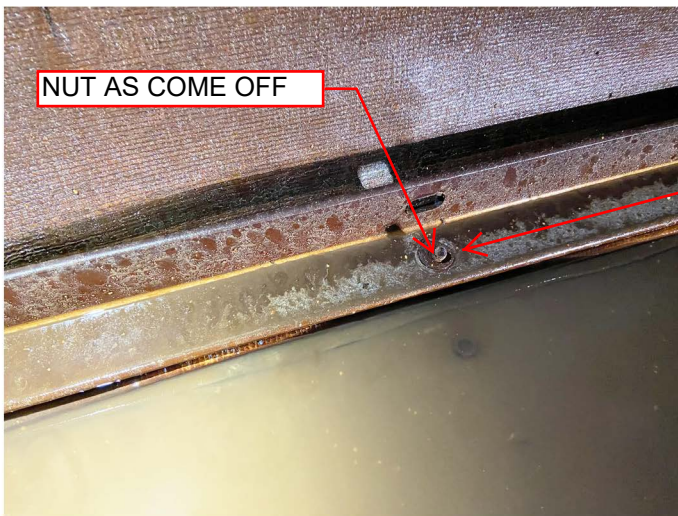
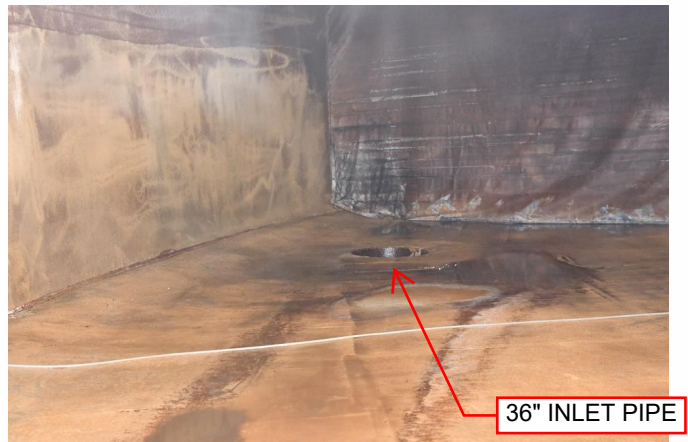
VIEWS OF TYPICAL
FLOOR
CONNECTIONS

LOOSE NUTS

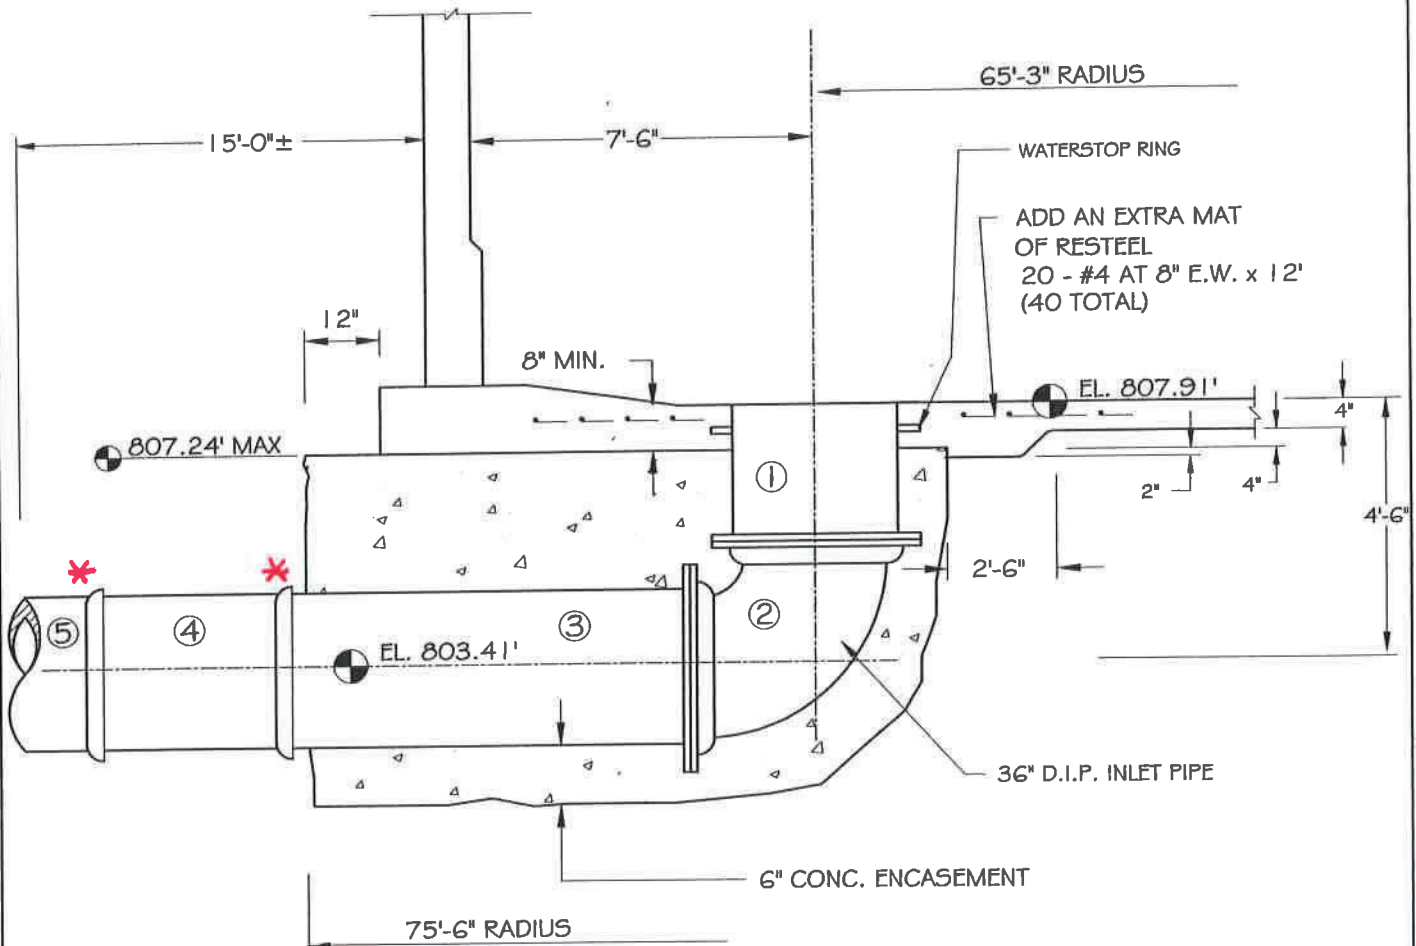
36" INLET LINE
NTS

Response: The floor thickness at the inlet pipe is depicted in the original project submittal as 8 inches in the vicinity of the inlet. See attached "36" INLET LINE".
